Simulation of 12 High Geosynthetic Reinforced Retaining Walls Under Surcharge Loading by Centrifuge Testing

James M. Klamerus
Hon-Yim Ko
University of Colorado
Department of Civil, Environmental
and Architectural Engineering
Boulder, Colorado 80309

Final Report
April, 1998

CDOT-DTD-R-98-6

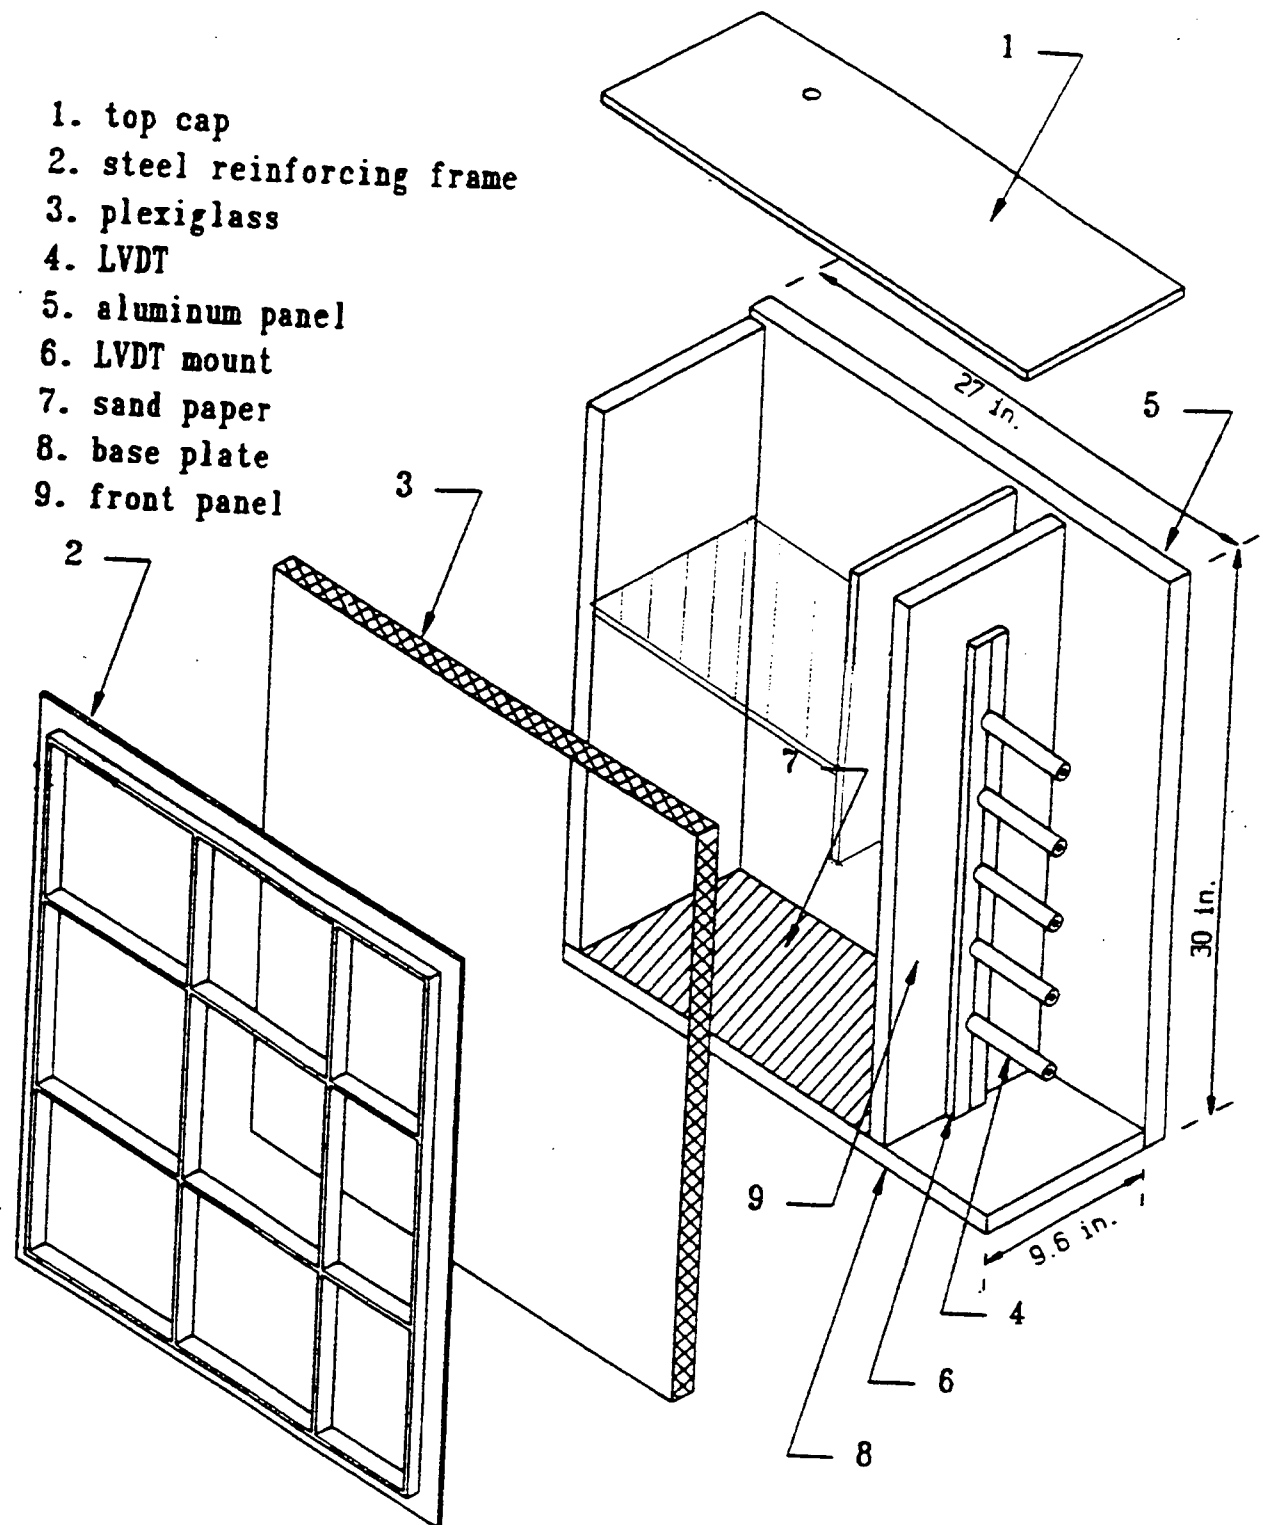
Figure 1. The schematic view of the container

The model was prepared in the container shown in figure 1. Silicone grease was applied to all interior surfaces of the container to reduce the edge effects of the container. A 0.2 mm latex membrane was attached to the plexiglass panel with a one inch square grid pre-drawn on the latex for visual enhancement of the displacement. A sheet of sand paper was glued to the

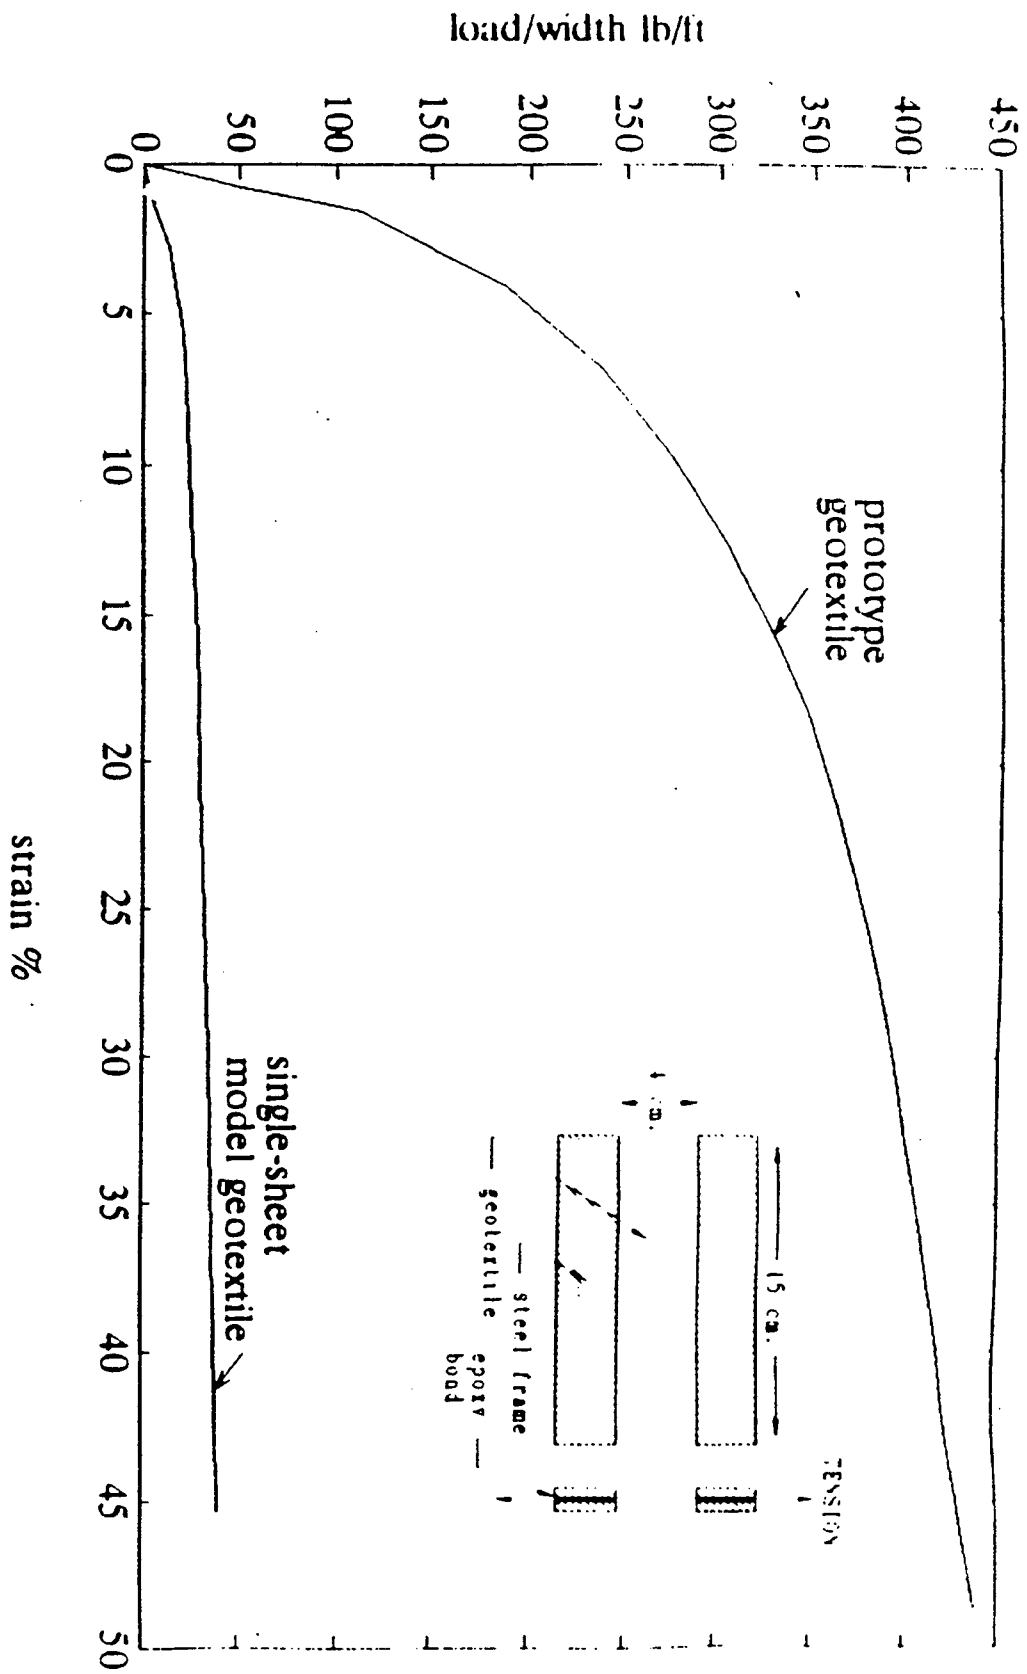
Figure 2. Load-deformation behavior of the geotextile and the configuration of the test setup

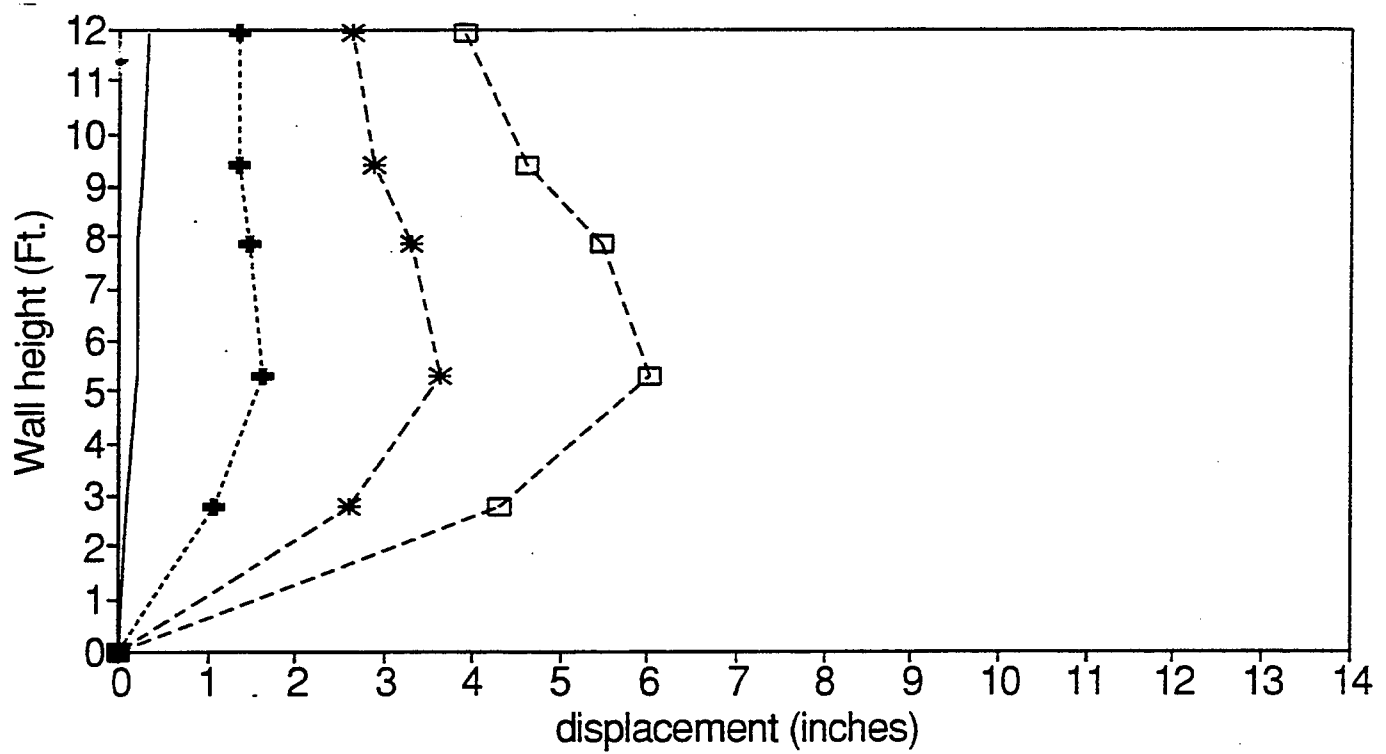
TEST 2

Wall face

— 5 Psi. --+-- 25 Psi. --*-- 50 Psi. --□-- 75 Psi.

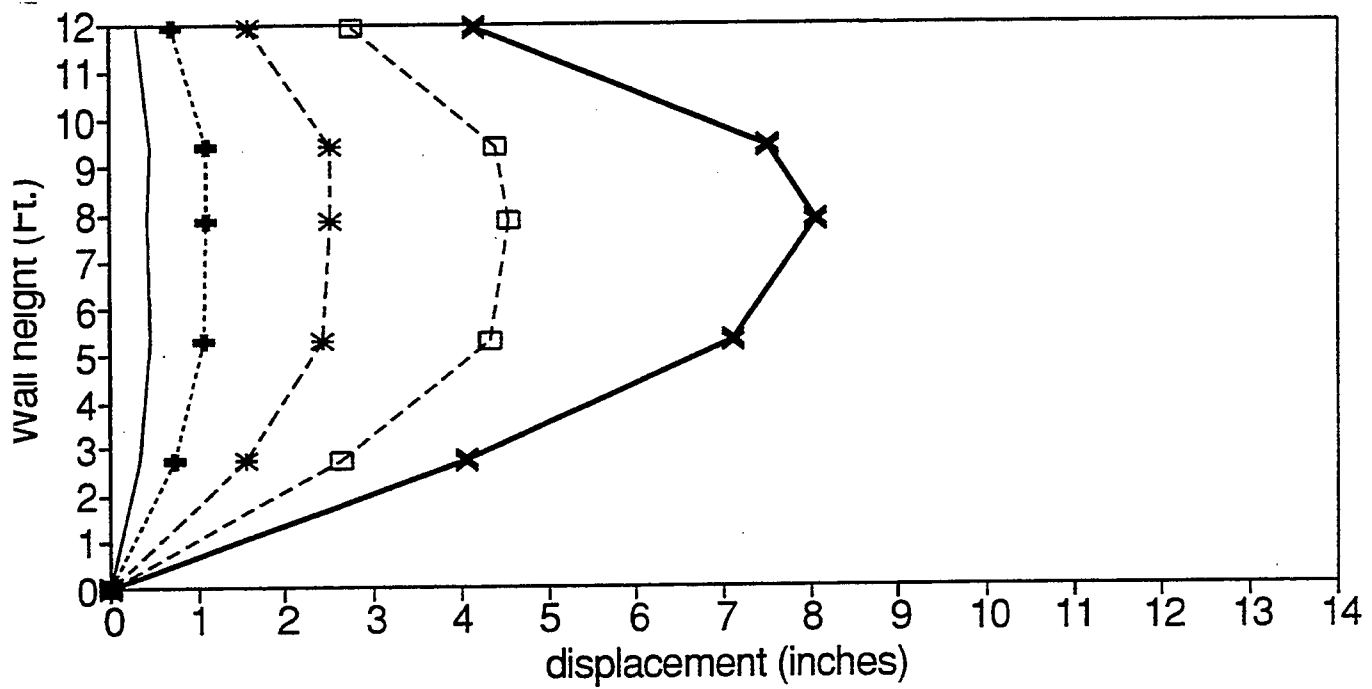
TEST 3

Wall face

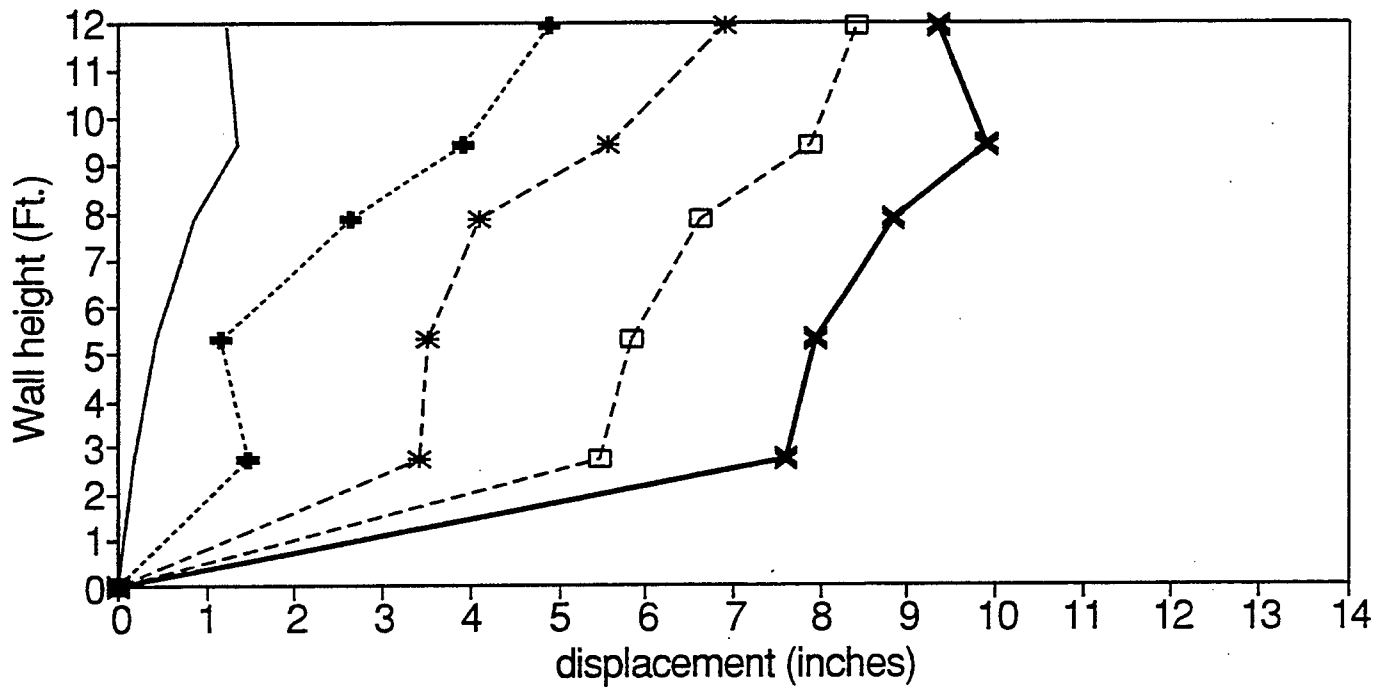
TEST 4

Wall face

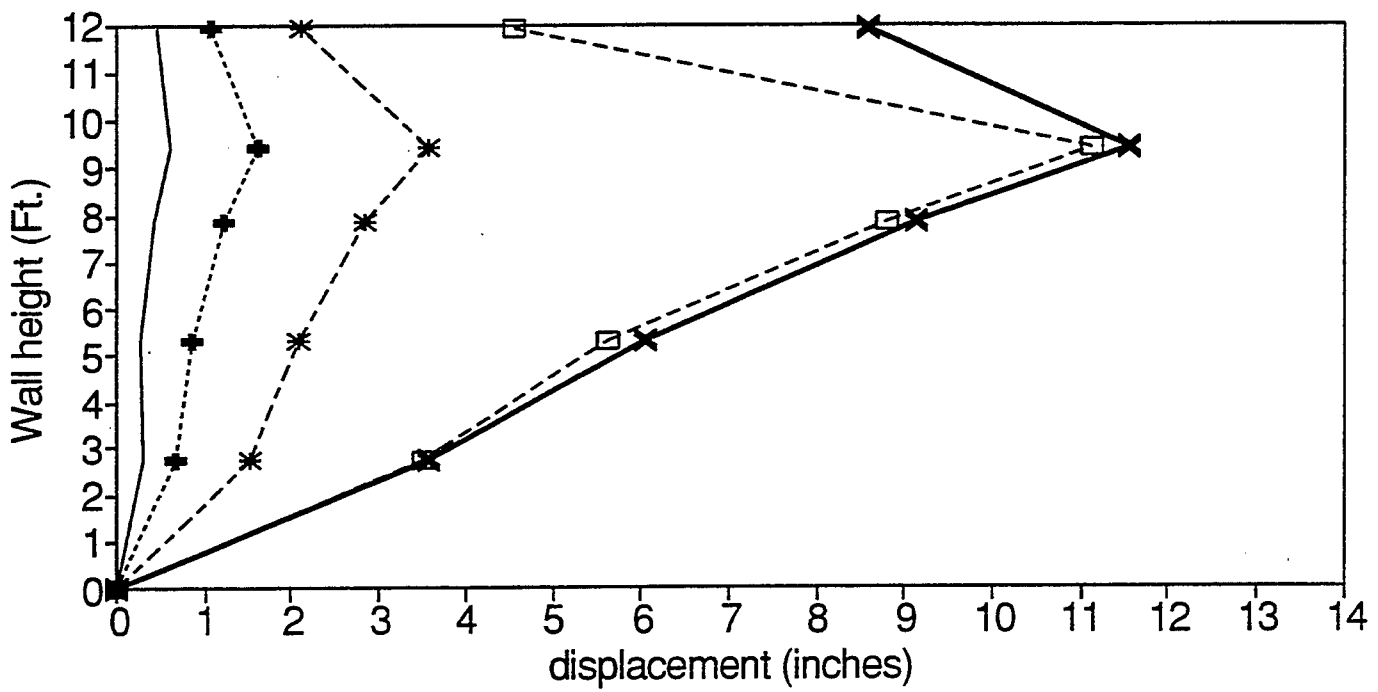
TEST 5

Wall face

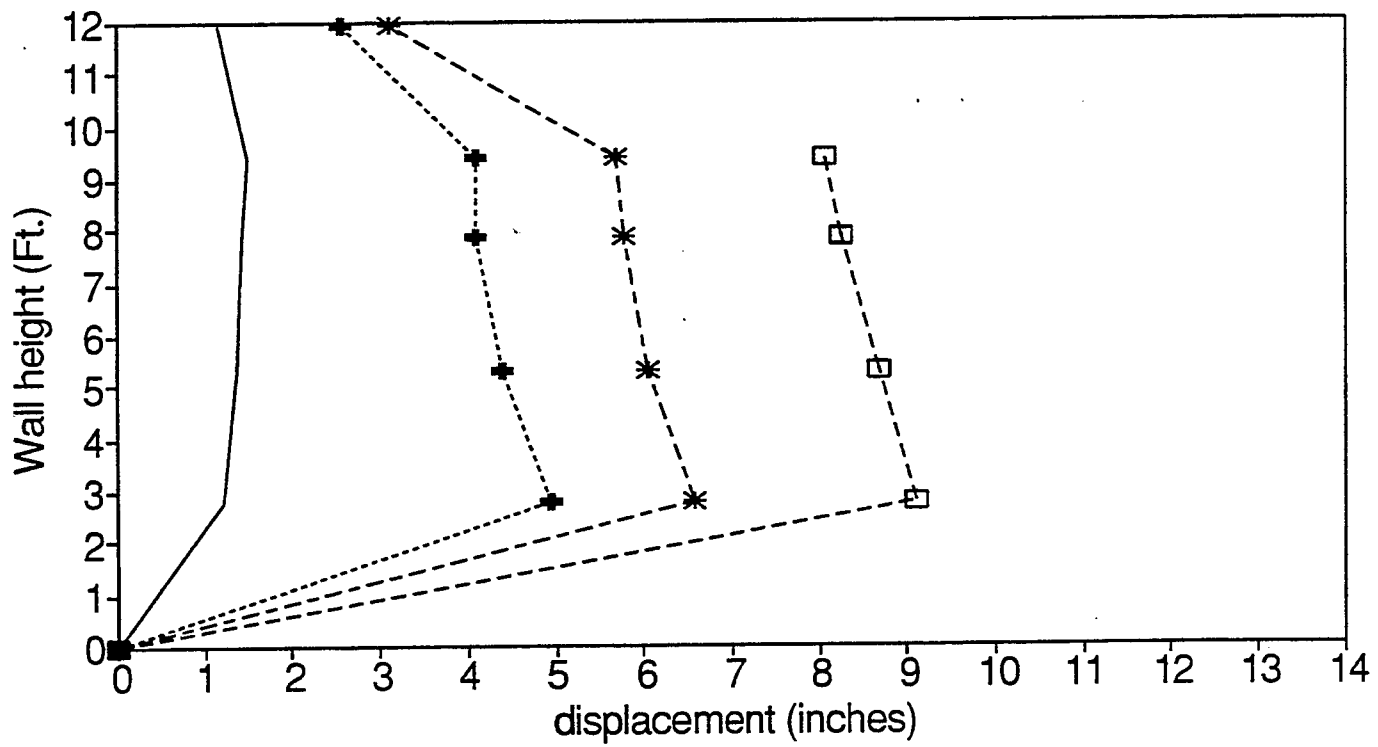
TEST 7

Wall face

— 5 Psi. --+-- 15 Psi. -*-* 25.Psi. -□- 35 Psi.

The comparison of test No. 7 and test No. 8 shows relatively low surcharge pressures of 30 psi. and 20 psi. required for 5% displacement. Without the material properties of the recycled asphalt one can not come up with a very logical explanation for this, but it may be due to the fact that, without any moisture and therefore no apparent cohesion and possibly low percent compaction, the appropriate strength of the walls were not achieved. The results, however show that recycled asphalt could be a viable backfill material for the type of reinforced wall construction. However, further investigation is required to arrive at affirm recommendation. It may be determined from these results though, that the rectangular and trapezoidal reinforcement shapes have similar structural integrity.

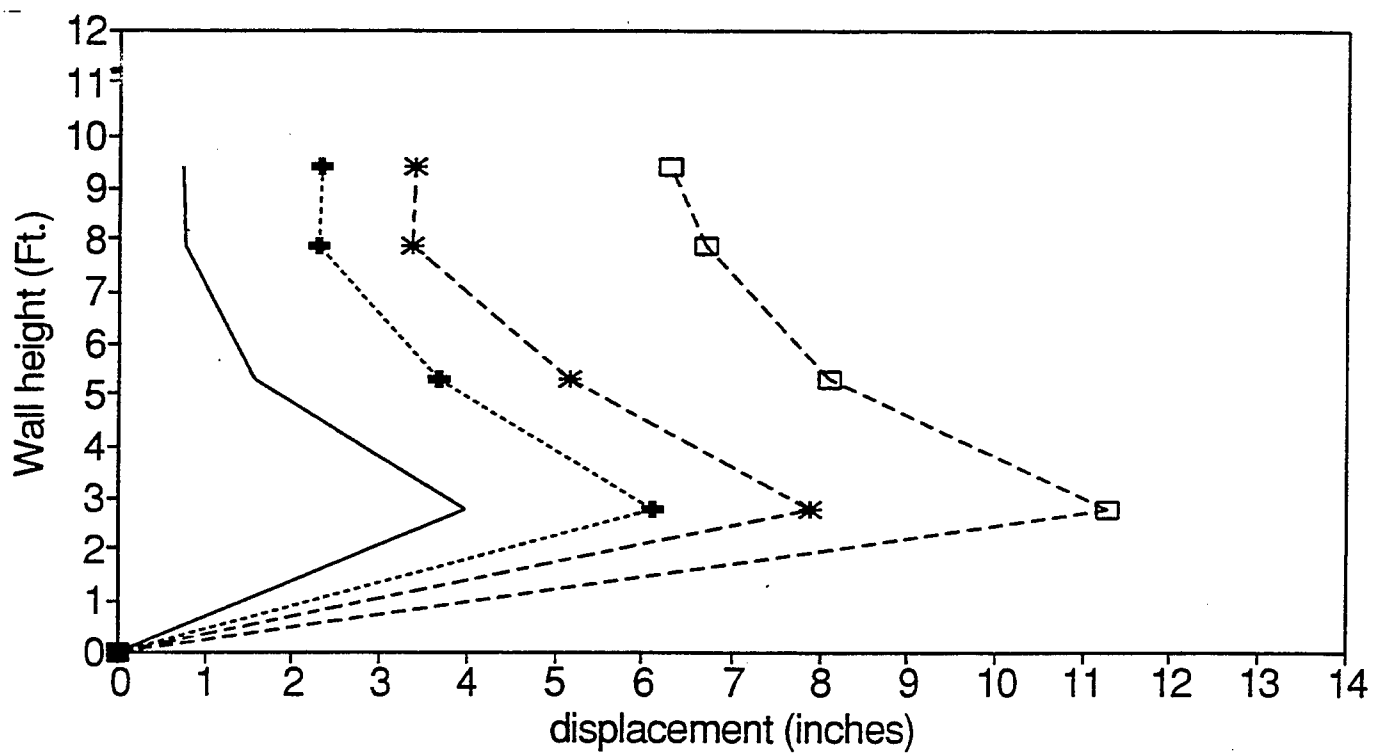
TEST 8

Wall face

— 0 Psi. --+-- 10 Psi. --*-- 20 Psi. --□-- 35. Psi.

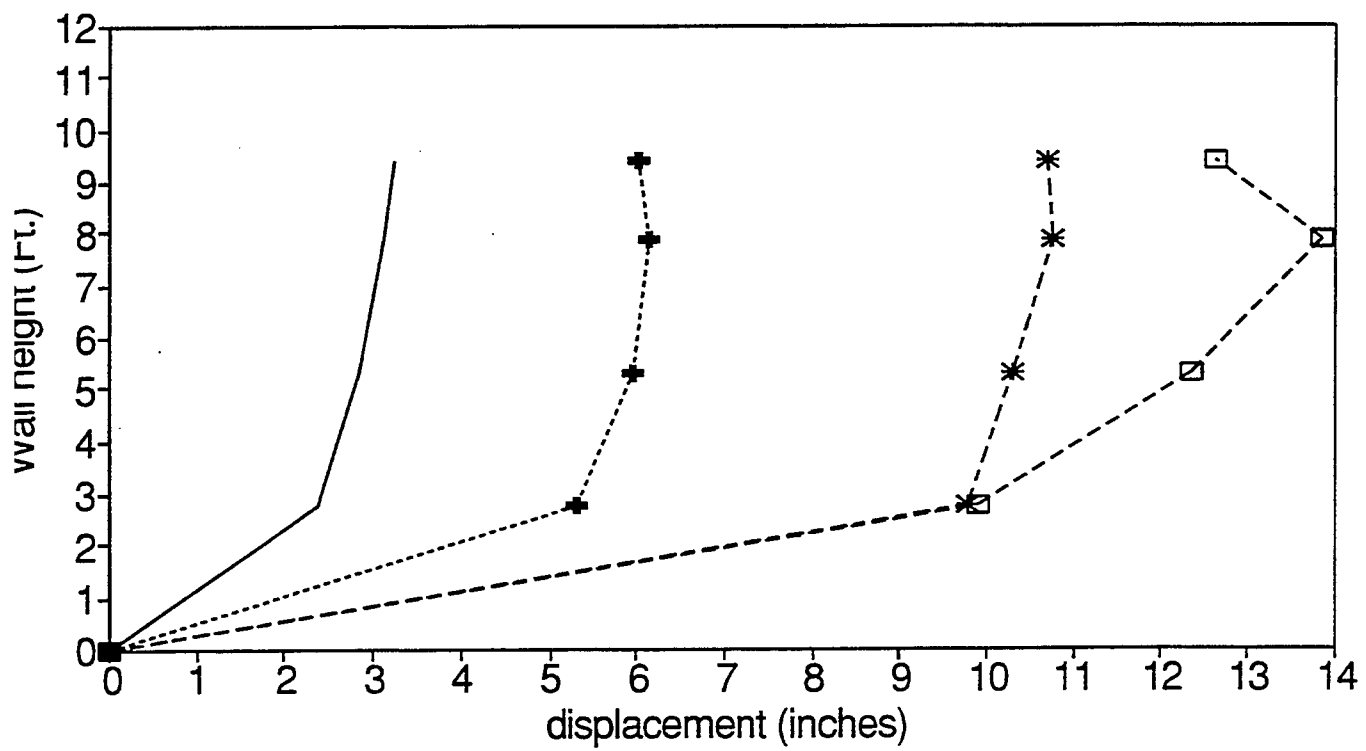
TEST 9

Wall face

— 5 Psi. -+-- 15 Psi. -*-- 25 Psi. -□-- 35 Psi.

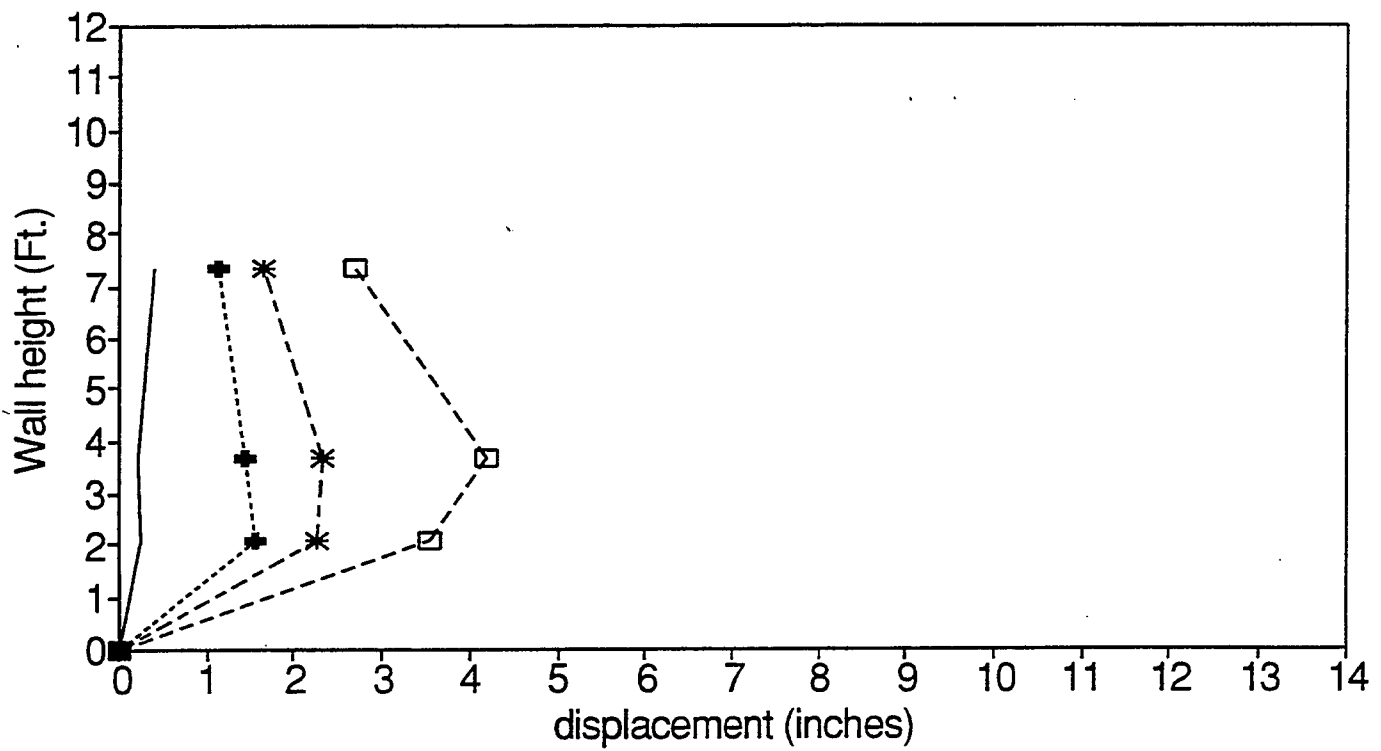
TEST 10

Wall face

— 0 Psi. -●- 10 Psi. -*- 20 Psi. -□- 30 Psi.

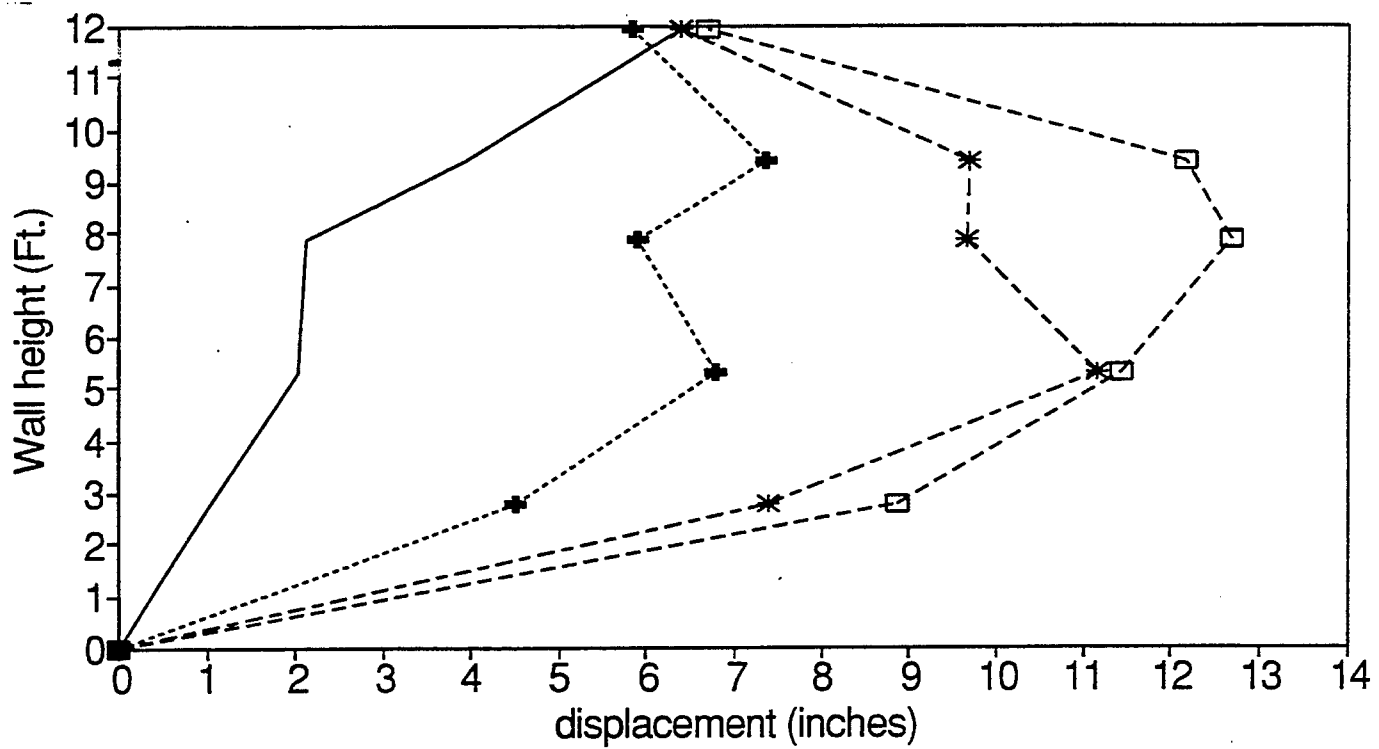
TEST 11

Wall face

— 0 Psi. -+-- 10 Psi. -*-- 20 Psi. -□- 30 Psi.

reinforcement with alternating layer of sand and clay that was allowed to saturate. Test No. 11 achieved 5% displacement at a relatively low 10 psi. of surcharge pressure, but the one result of this test that is of concern is that the observed failure plane as shown in photograph No. 11-1 is behind the end of the reinforcement layers. It is therefore concluded that as the angle of internal friction for the backfill material is reduced past some level, the lengths of reinforcement for the trapezoidal shaped reinforcement are not long enough for the wall to be considered stable.

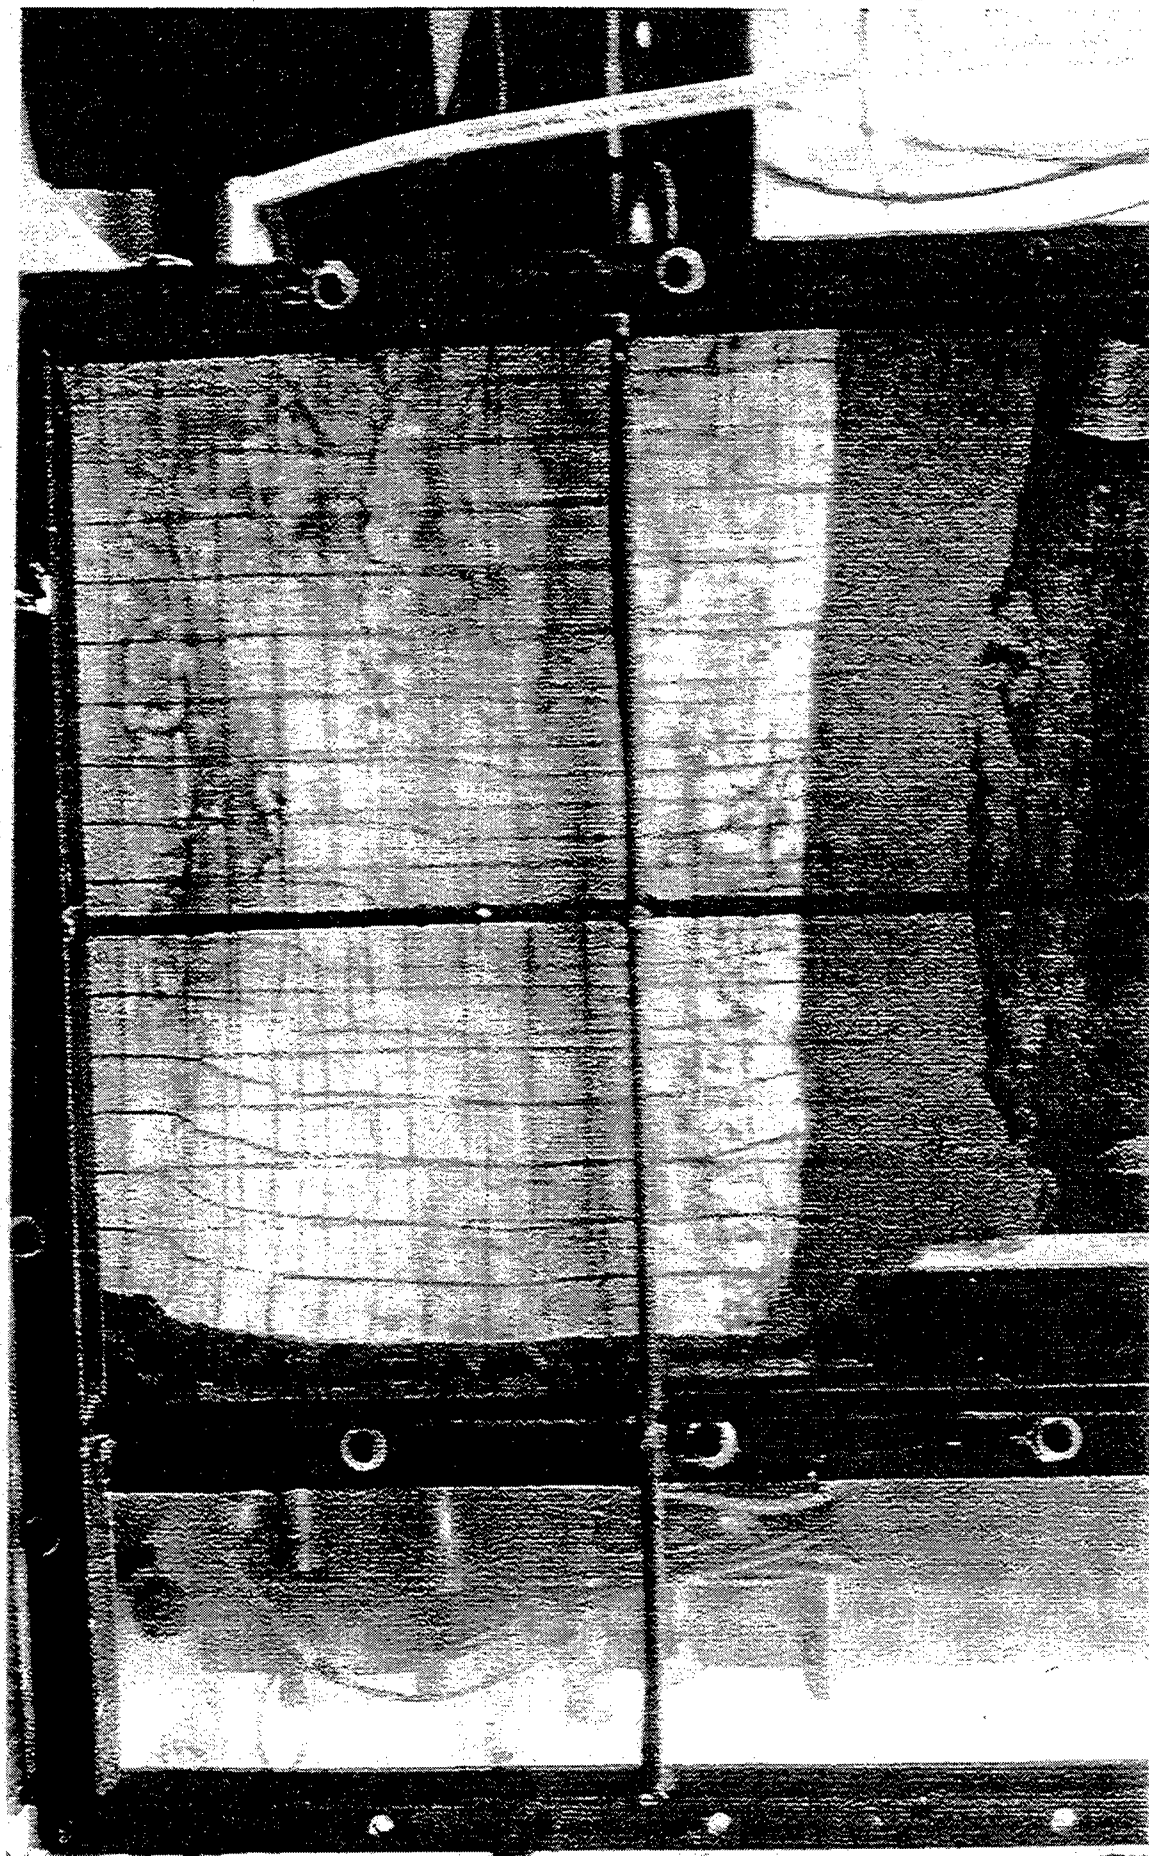
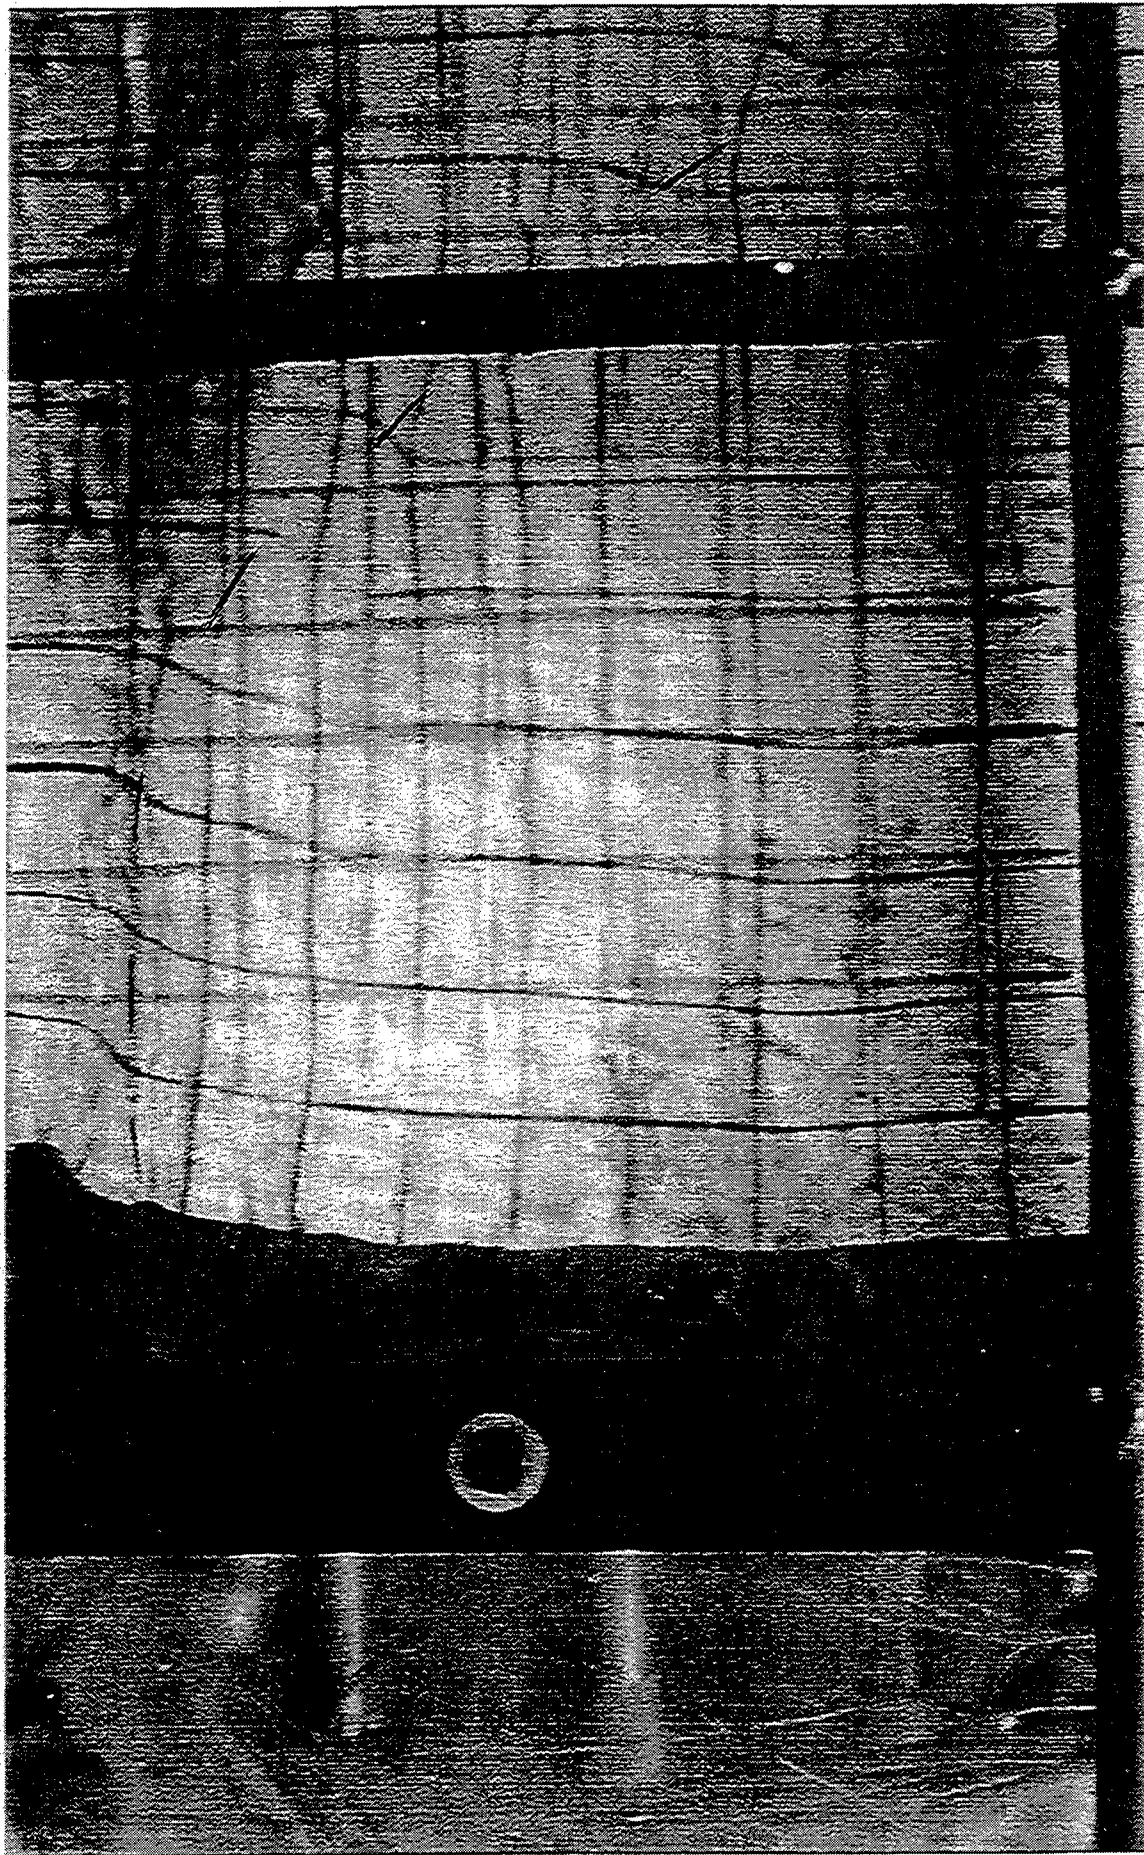
The back fill material was compacted in alternating layers of sand and clay. Sand was placed on the bottom layer. The sand was compacted at 15.2% moisture and the clay was compacted at 17.2% moisture. The container was sealed and filled with water and allowed to stand for 9 days. The low moisture content of the sand at the end of the test is probably due to water being spun out of the sand by the centrifuge during the test. LVDT No. 1 rode over the top of the wall at less than 11 G's so this data was not used. This is the first test with the new data acquisition system in the centrifuge. Test 11 did not get recorded on video tape. The shear surface of the failure plane was observed behind the end of the trapezoidal shaped reinforcements as can be seen in pictures 11-1 & 11-2.

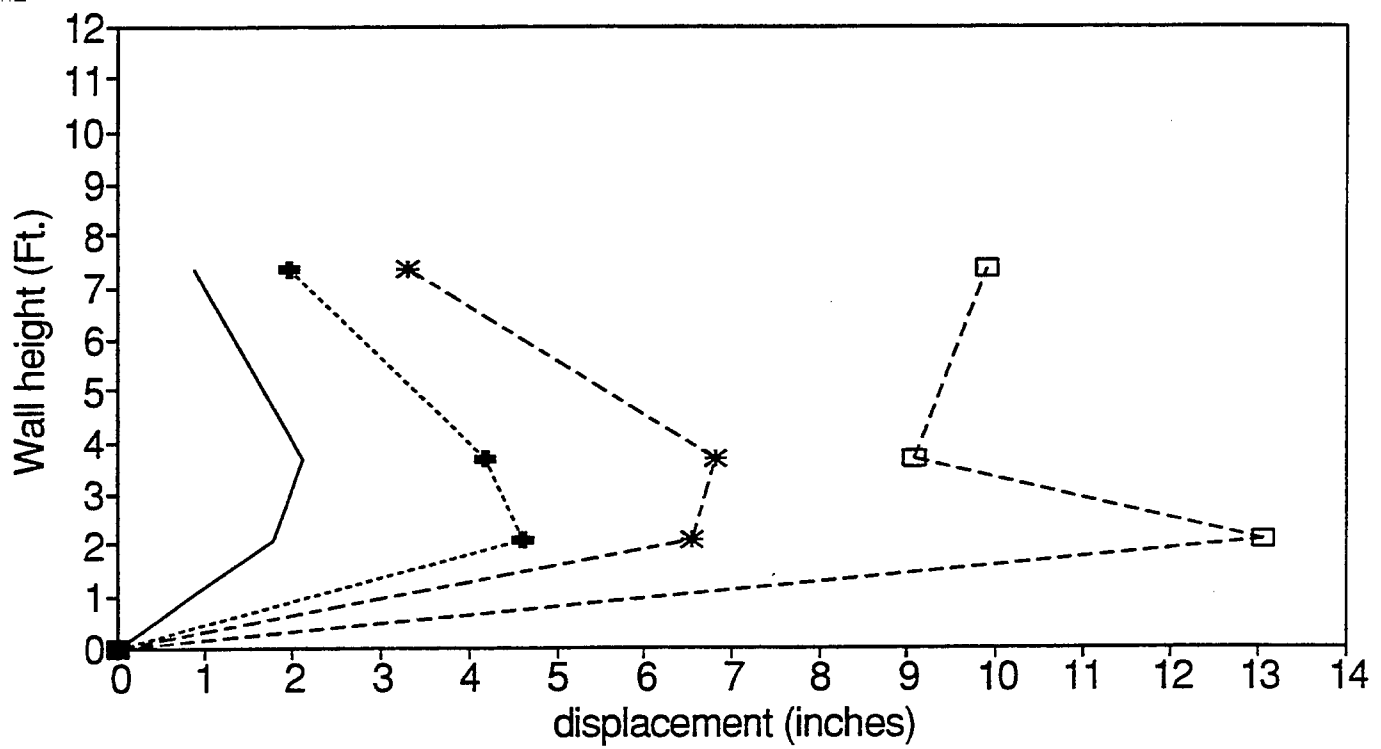
TEST 12

Wall face

— 5 Psi. -+-- 15 Psi. -*-- 25 Psi. -□-- 35 Psi.

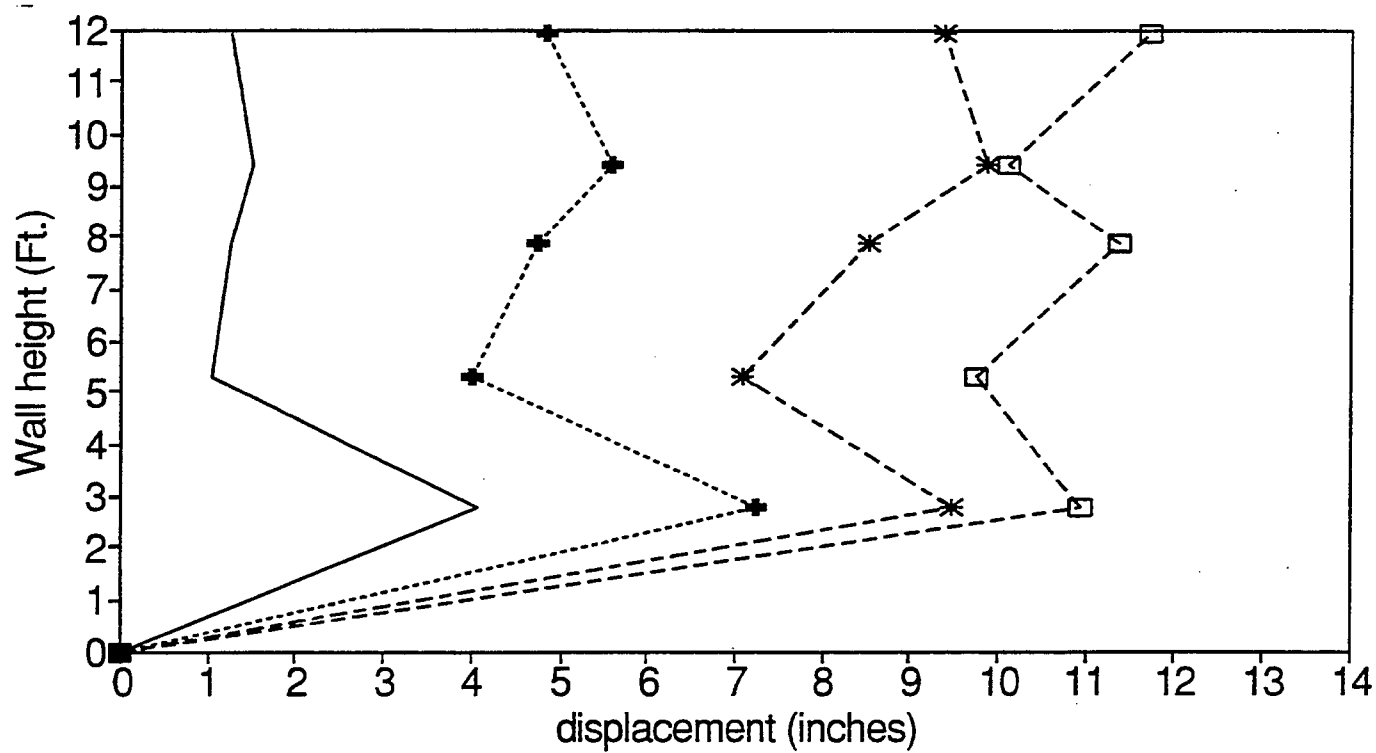
TEST 13

Wall face

— 10 Psi. -♦- 35 Psi. -*- 50 Psi. -□- 65 Psi.

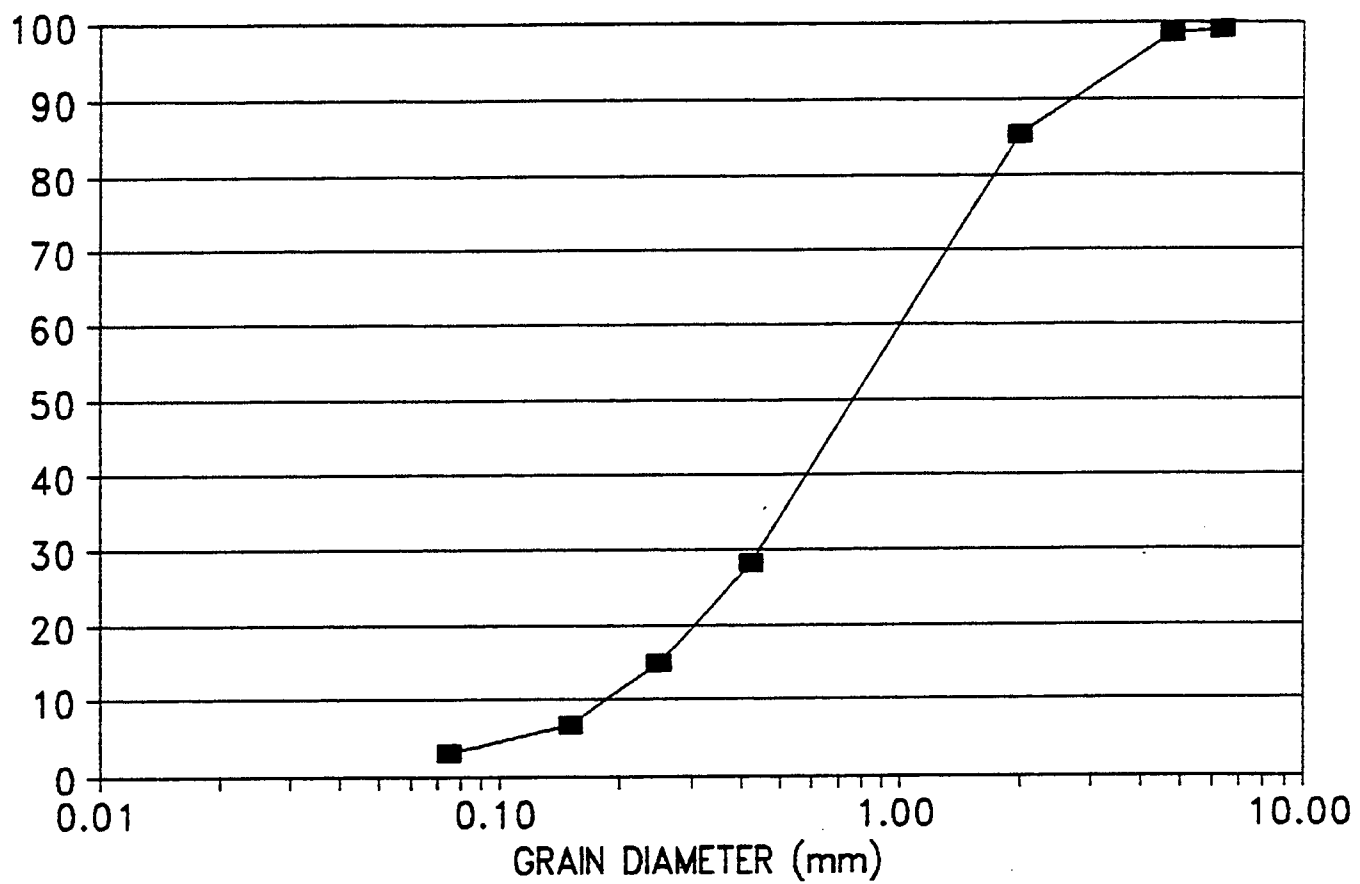
SIEVE NO.	SIEVE DIA.	WT RET.	%FINER
1/4 IN.	6.350 mm	7.6 g	99.1
#4	4.750 mm	4.7 g	98.5
#10	2.000 mm	105.2 g	85.4
#40	0.425 mm	456.6 g	28.4
#60	0.250 mm	108.6 g	14.8
#100	0.150 mm	65.1 g	6.7
#200	0.075 mm	29.2 g	3.1
PAN		4.7 g

GRAIN SIZE DISTRIBUTION SAND

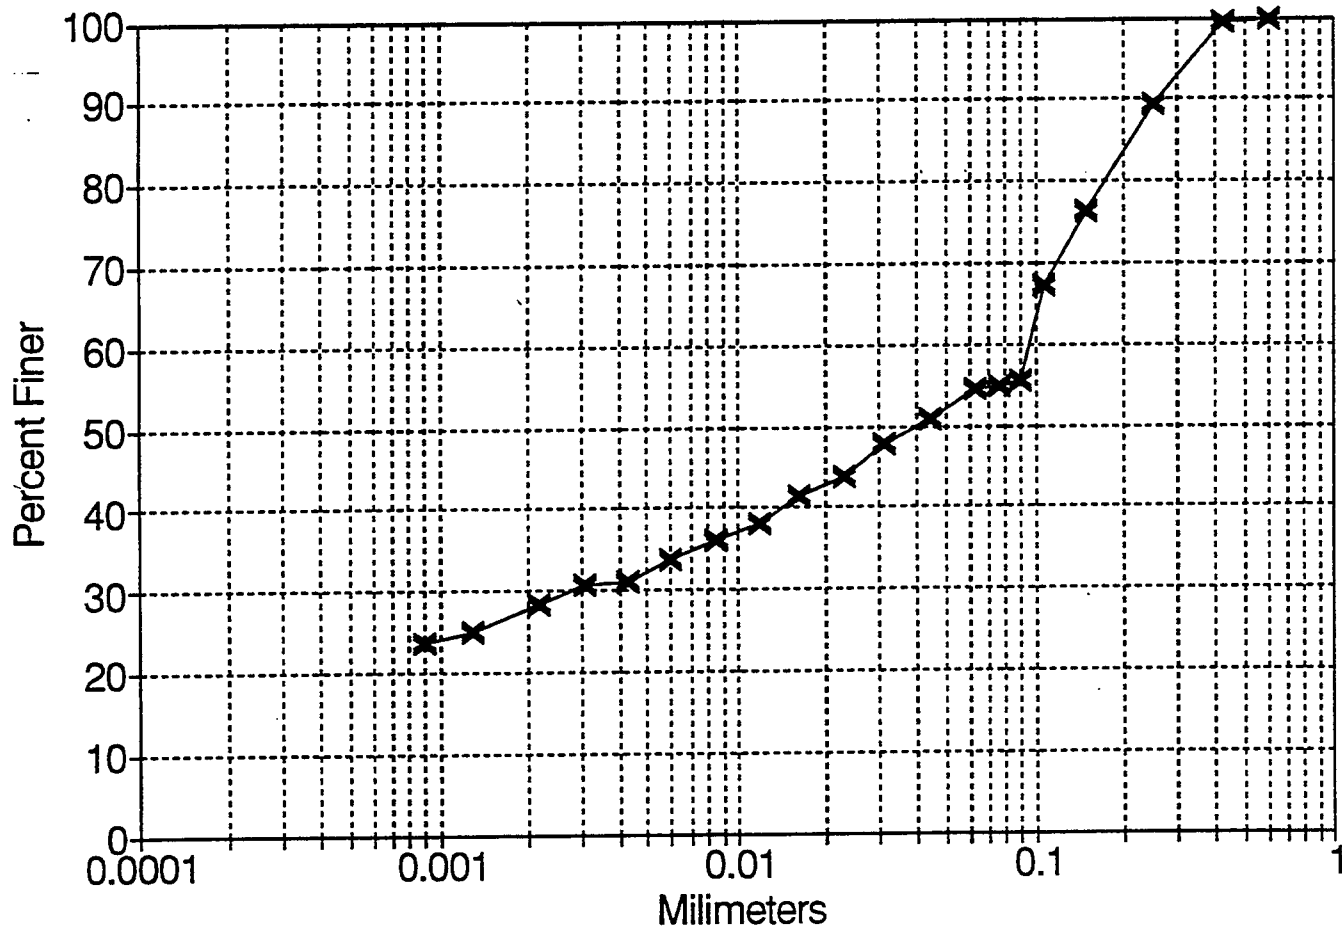
Sieve No.	Partical Diam. mm	Percent Finer
4	4.75	100
10	2	100
30	0.6	100
40	0.425	99.6
60	0.25	89.4
100	0.15	76.5
140	0.106	67.1
200	0.0884	55.3
	0.075	54.8
	0.0628	54.4
	0.0443	50.9
	0.0316	47.7
	0.0227	43.9
	0.0162	41.6
	0.0119	38.2
	0.0085	35.9
	0.006	33.7
	0.0043	31.2
	0.0031	30.5
	0.0022	28.3
	0.0013	25.1
	0.0009	23.8

Gradation of Silty Clay Backfill
